INSPECTION REPORT  
April 12, 1977

Mesa No. 2 Mine  
Navajo Allotted Lease  
14-20-0603-7240  
McKinley County, New Mexico

Dale C. Jones  
Mining Engineer  
May 5, 1977

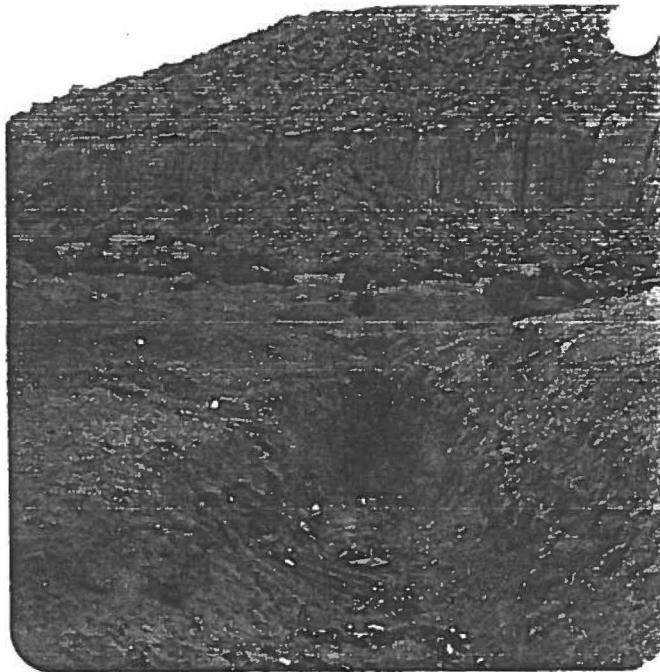
The portal of the southwest decline has been sealed, apparently by backfilling the opening with waste rock and dirt. Some timbering has been placed on top of the fill to support part of the portal, but there are no visible means of entry into the mine workings. The rock around the portal brow could be dangerous. The beginning cut of the incline remains open but does not appear to be dangerous as the cut is in consolidated rock. Garbage, evidently from nearby residences, is accumulating in the cut. A large pile of dirt, and possibly waste rock, is located at the entrance of the cut.

Southwest incline of Mesa No. 2 Mine  
(looking NNW); Haystack Mountain in background

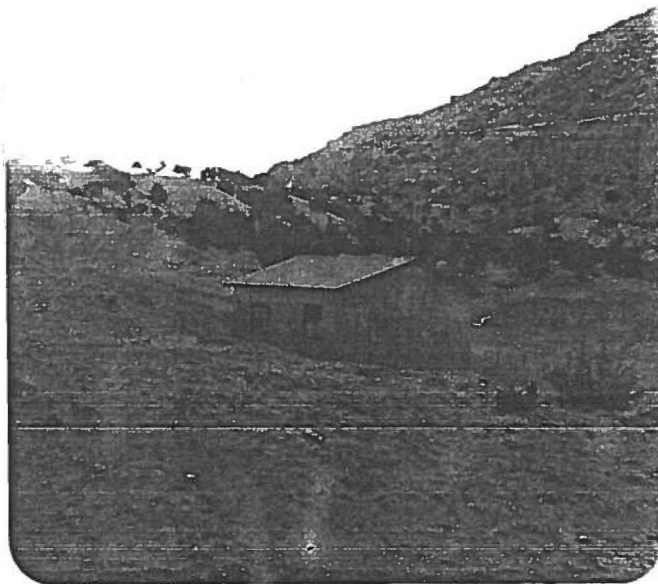
Small mine building near southwest  
incline shown in photo above

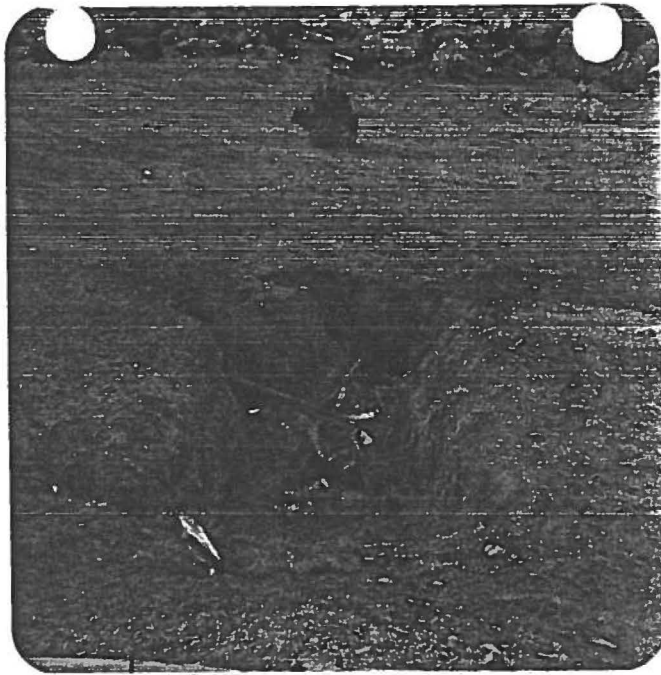
The northeast incline is partially sealed by a small cave-in at the portal, but it would be possible, and very dangerous, to enter the mine workings. The ground around the portal appears to be mostly very unconsolidated dirt which could cave very easily. This creates a safety hazard due to the close proximity of occupied residences. A flat-topped pad of waste rock and timbers is located near the incline entrance and evidently accommodated the diesel hoist. Directly behind this pad to the southeast is a small concrete pad which was evidently the floor of the small general purpose building. A low waste dump is situated southeast of the incline.

Northeast incline of Mesa No. 2 Mine (looking NNW from top of hoist pad). Base of Haystack Mountain in background; Timbers of hoist pad visible in lower left corner of photo

As previously stated, the involved lands are not currently under lease. The previous lease expired October 12, 1972, and it is assumed that the \$2000 surety bond was also cancelled at that time. The BIA will be contacted about the exact status of the bond. However, the condition of the northeast incline constitutes a serious safety hazard, and the writer recommends ~~that the writer recommends~~ that the appropriate agency take immediate action to mitigate this situation. Specifically, the northeast incline portal area should be fenced to prevent access, and all ventilation holes should be located to determine their condition as they too may require fencing. In addition, the deep trench made by Cibola Mining Company should be located to determine if any immediate mitigative measures are necessary.

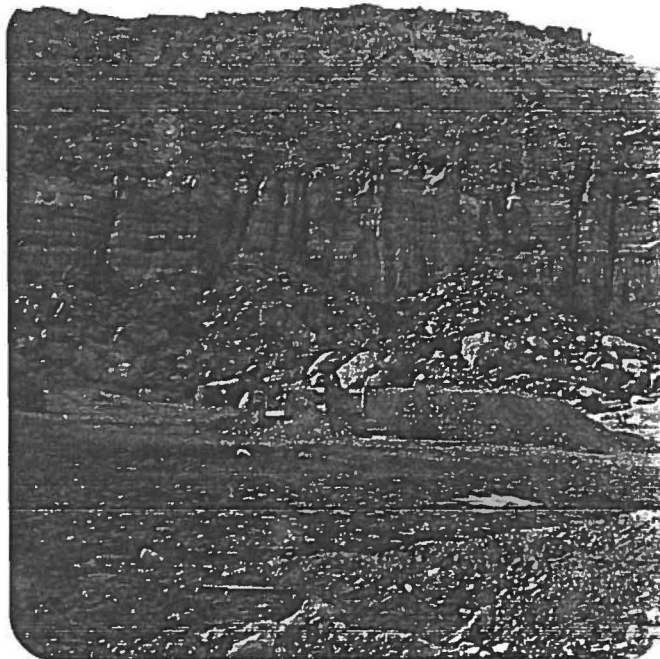
Hoist pad directly behind northeast incline; Haystack Mountain in background; part of waste dump visible in lower right corner of photo

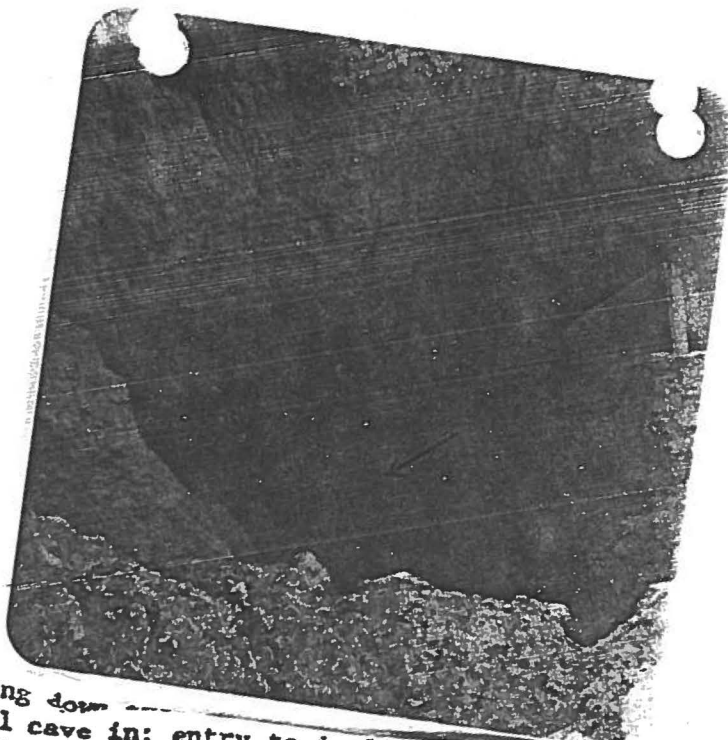
Looking down  
portal cave in; entry to incline possible through  
hole (arrow)

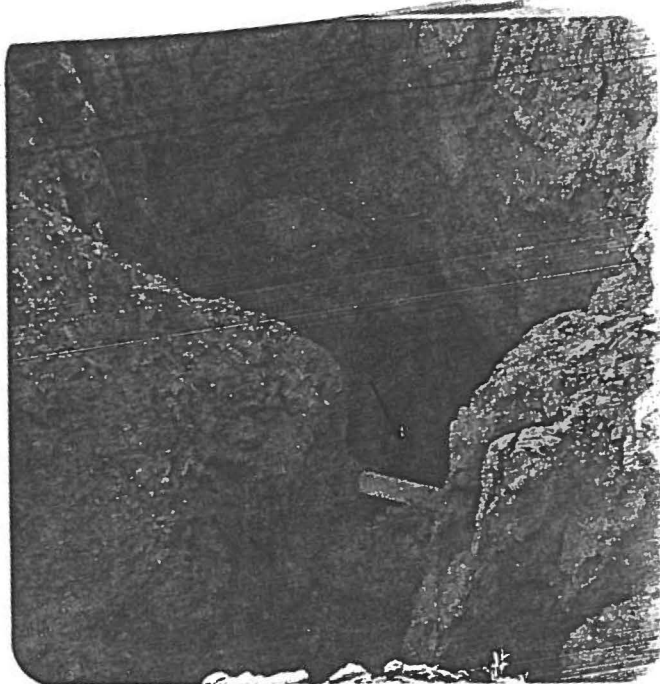
Same as photo above from a different angle; hole  
(arrow) is the same as in photo above
